Stanford eCorner

Classic Example of a Future Accident

Elisabeth Paté-Cornell, *Stanford University*

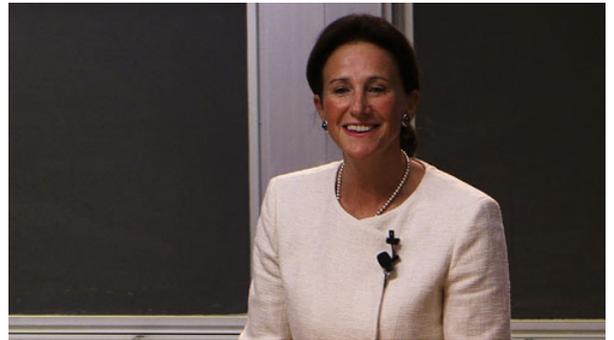
The classic example of an accident that hasn't happened yet: the heating tiles of the space shuttle. The first 33 flights consisted of errors in maintenance. Dr. Elisabeth Paté-Cornell describes how she discovered that technicians were mixing water with the glue, so the heating would adhere faster to the surface; though, by diluting the contacting bond, it put the heating tiles more at risk during the space shuttle's reentry into Earth. Her team created a map of the space shuttle and the most crucial heating tiles. In the end, she made recommendations based upon the data and research.

This is what the tiles look like. Each of them was about 8 inches. And the interesting thing is that they are glued on the lattice of filament. So each of them has to be glued in the cavity. And in order to gain some time, some of the technicians I found out, one technician at least, that this glue would cure faster if you add water to it. And what they were doing, in fact, was to spit in it. And so the glue was curing faster, alright. He was gaining time but of course that was a dangerous thing to do. So how did we think about it? Well, we look first at what happens, what's the accident mechanism? We have an initial loss of a bunch of them for two reasons: debris damage or debris hits, or deboning because there is weak bone. Then at re-entry, there is a cavity.

Now, the flow of gases heats up that cavity, you can then lose additional tiles. You expose the aluminum of the Orbiter, you can have then hot gases inside, the sub-system malfunctions, and you lose the whole mission. So the way we looked at this was by decomposing the system into these different parts, getting all the data that we could. Some of them was statistics, for example, we could get the measurements of temperature on the shuttle skin. Some others, we needed to go to expert opinions. That's what I put in there. So what did we find? We find that in fact, the tiles were not as bad as the astronauts feared, and we showed them a map on which we have identified the most risk-critical tiles so that if you had a bit more time to test something before launch, you could start there. We made all kinds of recommendations for improvement. Some of them were listened to, some of them were not. And unfortunately, the payload where the Columbia accident where again, one of the pieces of debris from the external tank hit the Orbiter and caused the failure.

This is the thing of beauty that I presented to Kennedy Space Center and what I had put in darker tones were the most risk-

critical zones. And we had computed the risks in each of the different zones. It's not symmetric because there are fuel lines running on the external tanks that weakens the attachment of the insulation. But these was used. It was put as a huge map on the floor and what they did was to test first and to show me they had done it, the places that were put in dark.
